Manhole Inspection Summary

Manhole # S35QQ_018MH

Insp Date: **1/22/07 9:41 AM**

Location Address: **104 25TH ST**

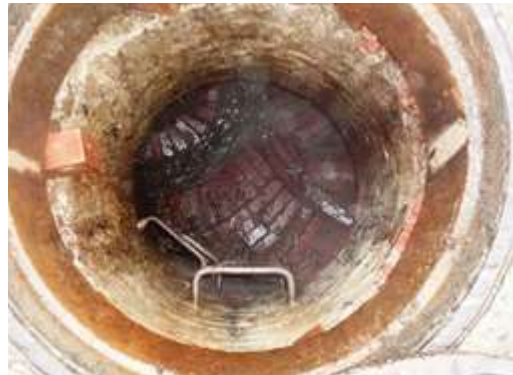
Top View

Bench debris.

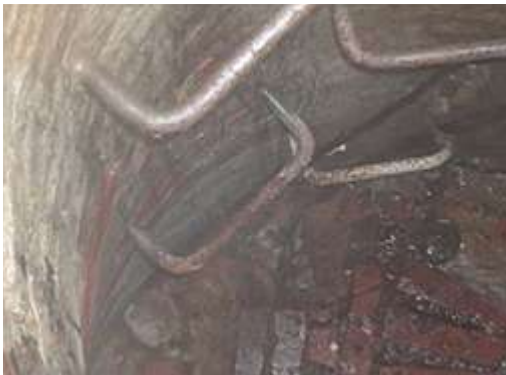
Defect

Corroded steps.

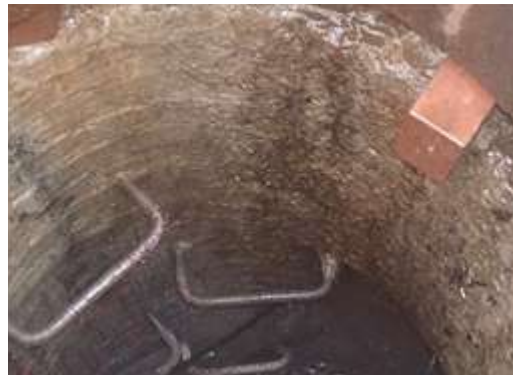
Defect

Frame Offset: **0** (in.) Condition: ☐ Sound ☐ Cracked ☒ **Leaks**

Condition: ☐ Sound ☐ Cracked ☐ Root Intrusion ☒ **Loose Brick** ☒ **Deteriorated**

Infiltration: ☐ None ☒ **Joint** ☐ Cracks ☐ Mortar ☐ Roots ☒ **Wall**

Frame leaks. Adjustment deterioration, loose brick and infiltration.

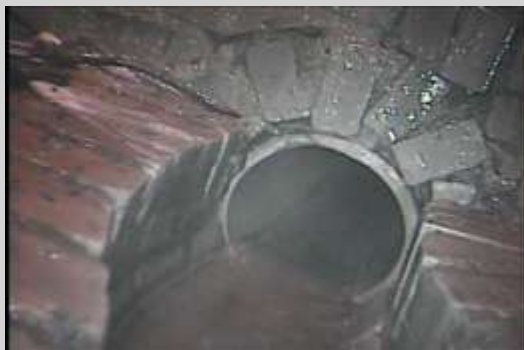
8 in. Circular Gravity Sewer

Comments **There is active infiltration in the Barrel.**

Condition: ☐ Sound ☐ Cracked ☐ Root Intrusion ☐ Loose Brick ☒ **Deteriorated**

Infiltration: ☐ None ☐ Joint ☐ Cracks ☒ **Mortar** ☐ Roots ☐ Wall

Barrel deterioration and infiltration (Active).
